# ARCHÆOLOGICAL DEPARTMENT

# SOUTHERN CIRCLE, MADRAS

1915-1916

# ARCHÆOLOGICAL SURVEY DEPARTMENT SOUTHERN CIRCLE, MADRAS

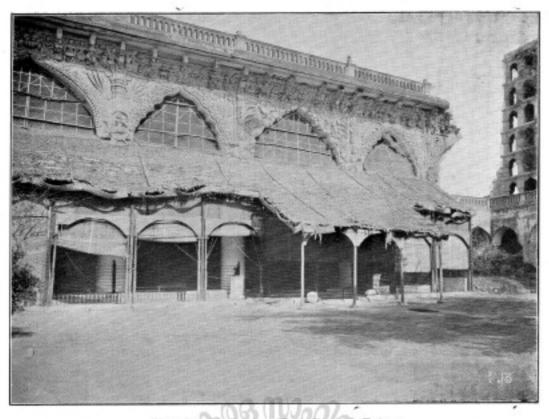
## PLATE XVI (a)

The Nayak's Durbar Hall, Tanjore Palace. (Before Repairs.)

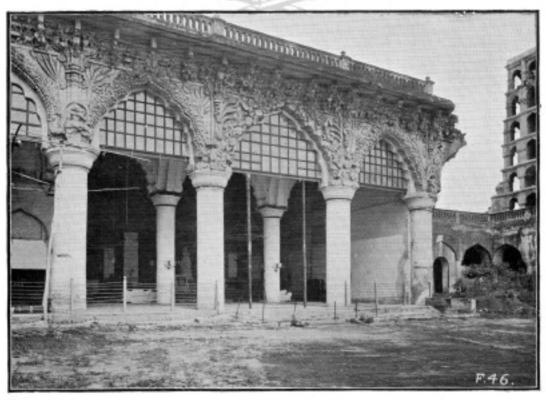
# PLATE XVI (b)

The Nayak's Durbar Hall, Tanjore Palace.
(After Repairs.)

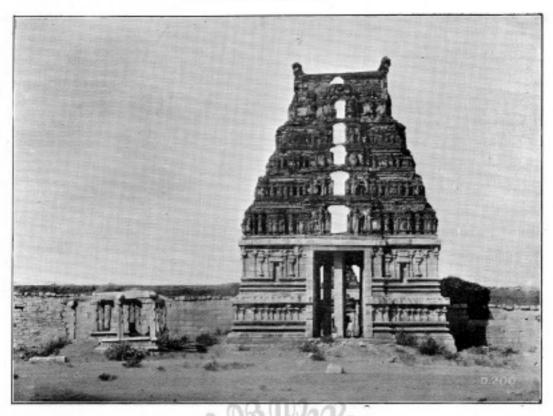
## PLATE XVII (a)

East Gateway of the Pattabi Rama Temple, Vijayanagar, Bellary District. (Before repairs.)
